⑥ National Dam Inspection Program.  
Bryant Pond Dam

BRYANT POND DAM

NDI ~~to~~ Number PA-00544  
DER ID Number 40-11

PHASE I INSPECTION REPORT

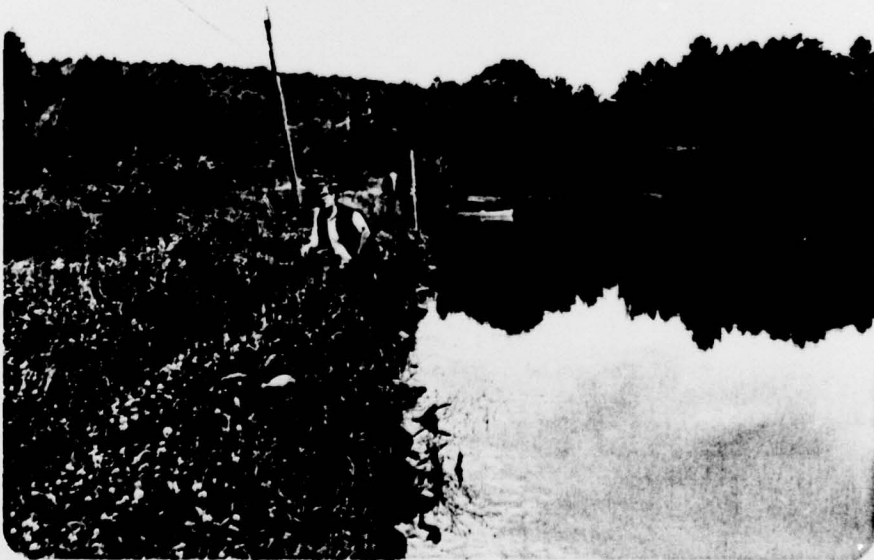
b. Embankment. The embankment is in very poor condition. Thick brush is growing along 50 percent of the upstream slope and at the right abutment of the downstream slope. The upstream slope in the 60-foot long reach that was breached during Tropical Storm Agnes is vertical with evidence of a minor amount of erosion. The top width in this breached area is 6 feet. The Owner reported that this area was repaired after Tropical Storm Eloise, but that he had insufficient funds to complete the repairs. Therefore, the downstream slope of the repaired breach section has been left vertical for 4 to 5 feet. At the bottom of the vertical drop, rockfill extends to the toe of the slope. At the top of the dam in the breach area, a 1-foot by 2-foot by 6-inch deep depression was observed.

B. Upstream Slope

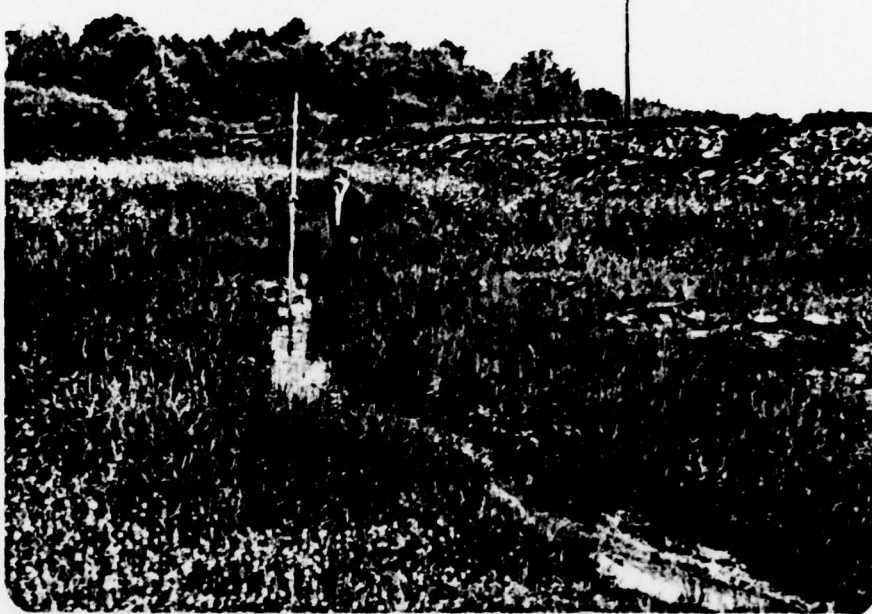
The rockfill on the downstream side of the core-wall is very uneven. Beneath one of the ice chutes it is washed out. The rockfill is covered with large, broken pieces of concrete. Some of these are part of the core-wall. The Owner reported that others are the remains of an old ice house that he used in lieu of rockfill to repair the embankment. Seepage was observed downstream from the embankment. Directly at the toe of the embankment a seep estimated at 1 gpm was flowing from a 200 square foot wet area. About 50 feet downstream the seepage increased to about 10 gpm at a localized area. This seepage then flowed to the creek. At the creek, the total seepage was estimated at 20 gpm. As a result of the previous overtoppings, the entire area downstream from the dam is covered with sediment and debris. Additional seepage was observed near the outlet works, as described hereafter.

C. Downstream Slope and Seepage

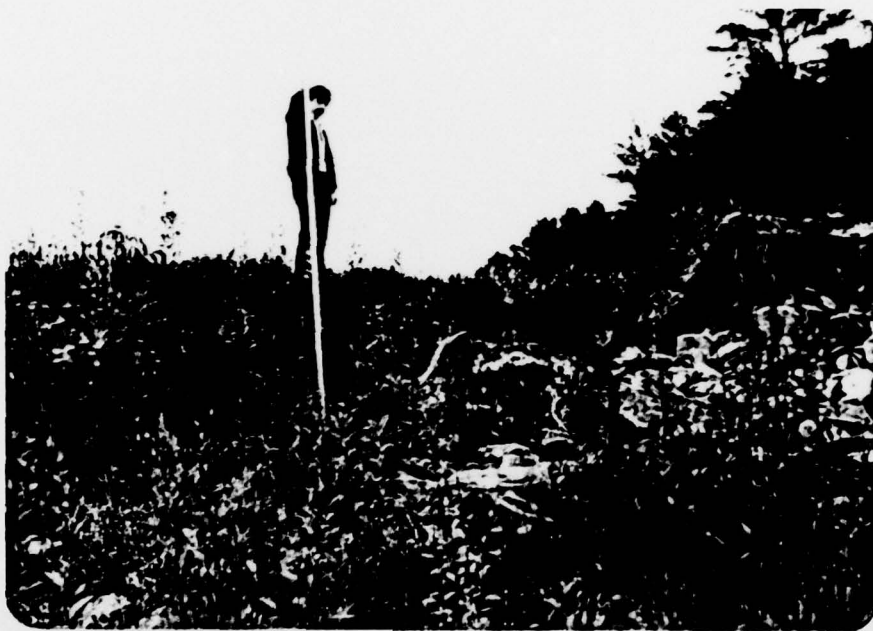
E. Breach Area

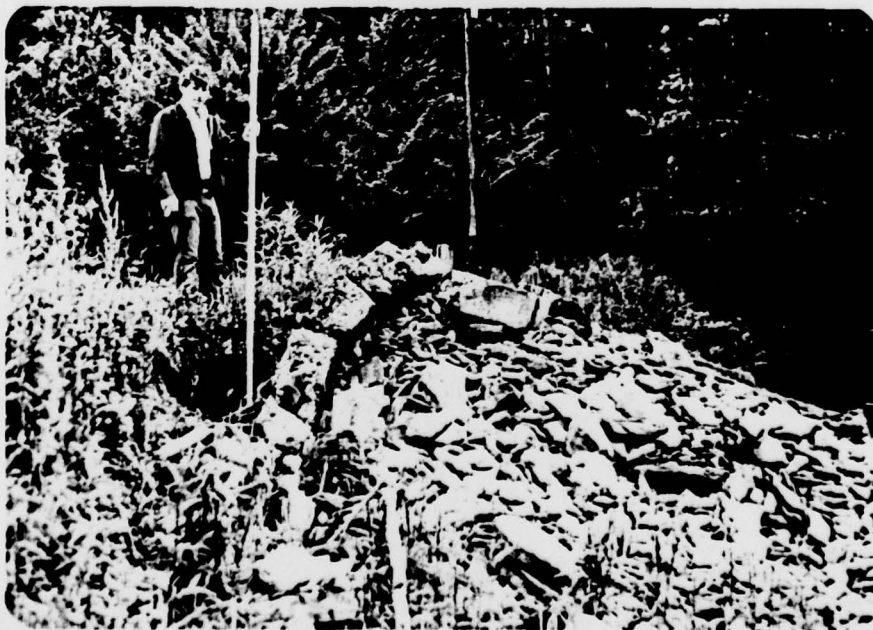
F. Breach Area

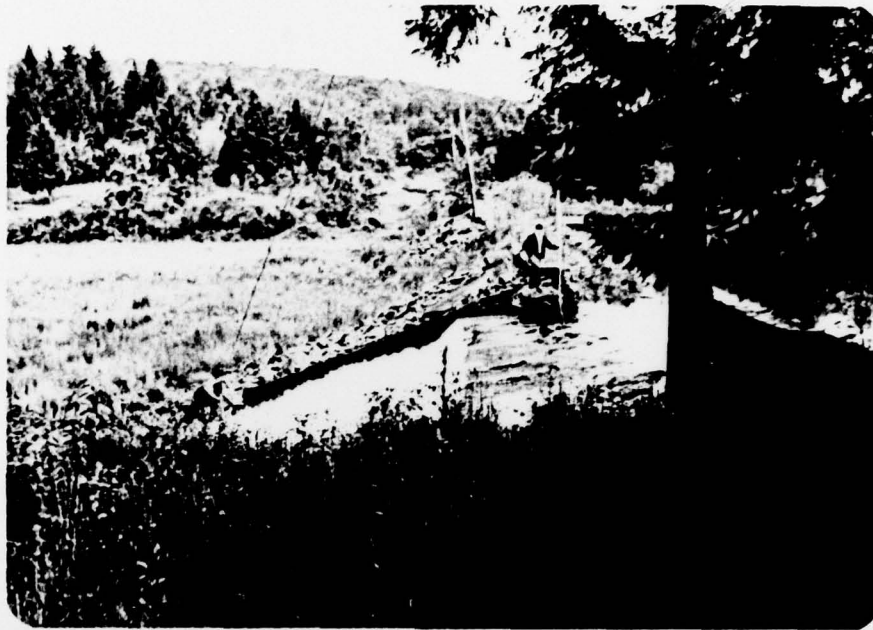
c. Appurtenant Structures. The spillway is in fair condition. As water was flowing over it, a detailed visual inspection was not possible. It was noted that the downstream edges of the cascades were jagged and eroded. Cracks were observed in the cascade slabs. The spillway walls along the cascade are low. The top of wall is 0.6 foot above the cascade at one point. The area to the left of the left spillway wall is rockfill covered with poorly placed concrete. At the downstream toe of this area, seepage estimated at 10 gpm, including a localized seep of 5 gpm, was observed. The core-wall to the left of the spillway is intact. Cracks, which extend entirely through the structure, were observed at 4 locations. The wall is tilted forward near its center; it is also bowed.

G. Spillway

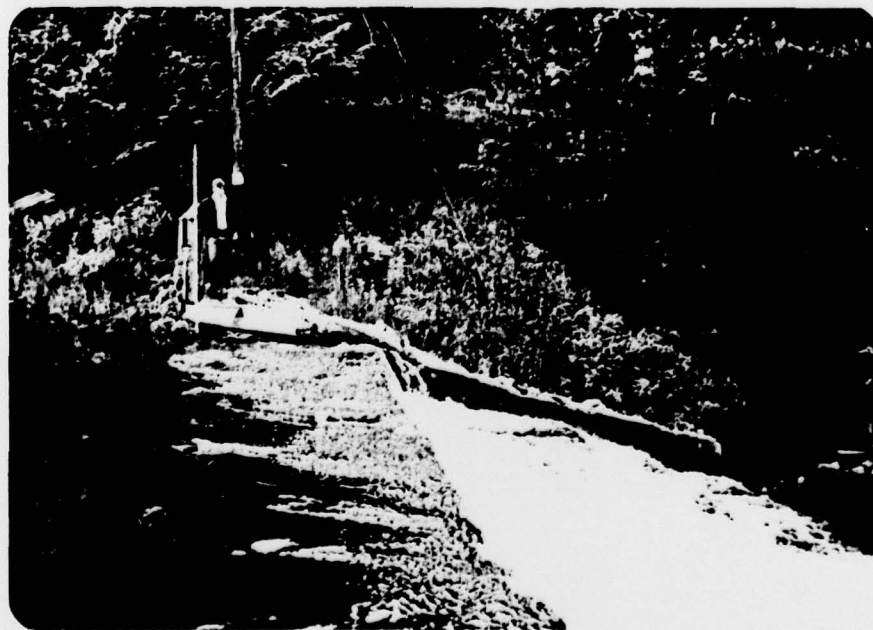
H. Spillway

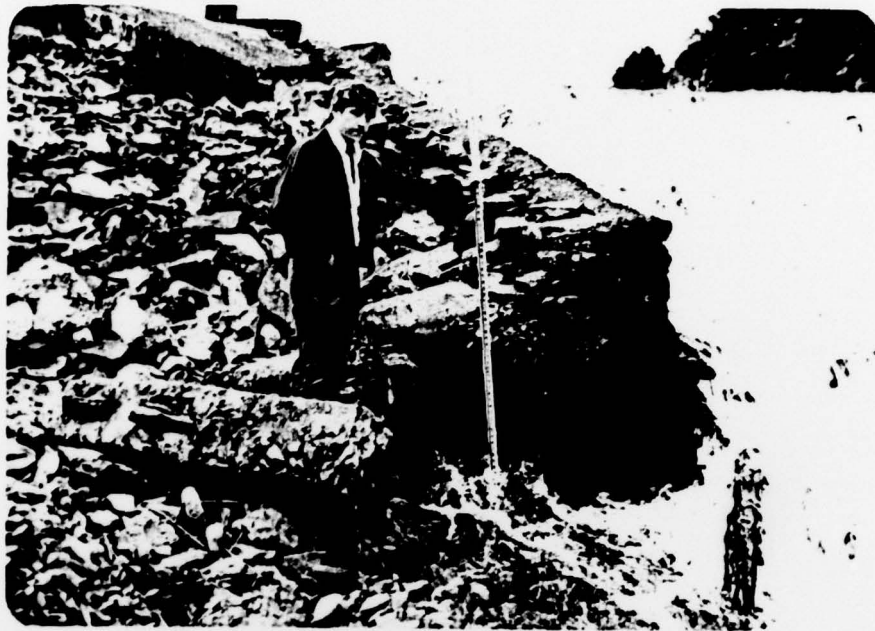
The outlet works is in very poor condition. The remains of the gate operator were observed immediately upstream of the spillway. At the downstream end, a flow of about 1 cfs was discharging from the right conduit. No flow was visible from the left conduit. Although the conduits were reportedly constructed of concrete, they appear to be dry masonry covered with concrete. It is possible to see daylight through the left side of the left conduit. Seepage estimated at 20 gpm was observed

I. Outlet Works

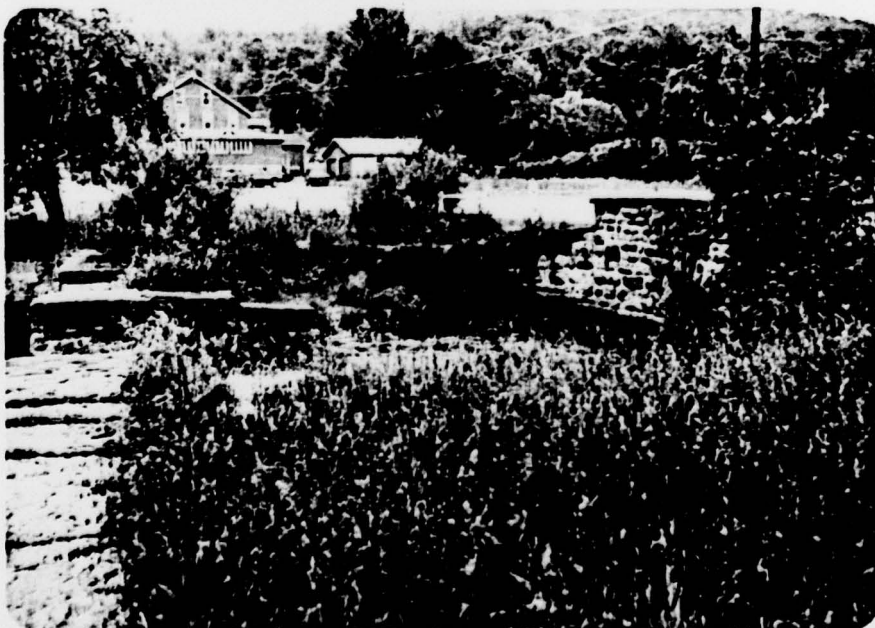
J. Harveys Lake Dam -  
Upstream From Bryant Pond Dam
